# Testing of Carbon Steel Pipe and Stainless-steel Duplex Pipes of Welding Joints: A Cost and Time Perspective

Alamsyah<sup>1\*</sup>, Ryo Herlambang<sup>2</sup>, Rodlian Jamal Ikhwan<sup>3</sup>, Taufik Hidayat<sup>4</sup> and Wardina Suwedy<sup>5</sup>

<sup>1,2,3,4</sup>Department of Naval Architecture of Institut Teknologi Kalimantan

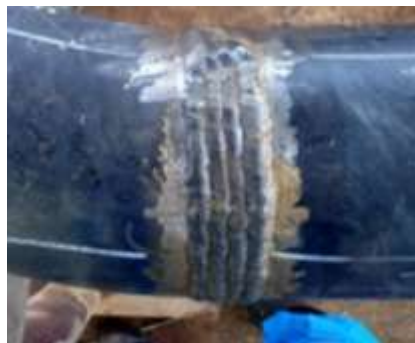
Radiographic testing was carried out on 10 (ten) sections of ASME SA 106 Carbon Steel pipe material with a diameter of 8 inches with a thickness of 20.6 mm, so one of the welded surfaces is shown in Figure 1 below:

Figure 1 Surface results of welding sections 5-10 inches

Welding uses the GTAW-SMAW welding method. The test results and radiographic film observations showed that there were no weld defects in that part. This 5-10 inch section is marked with film code 2 (two)/sheet 2 (two), the film tested is shown in Figure 2 below:

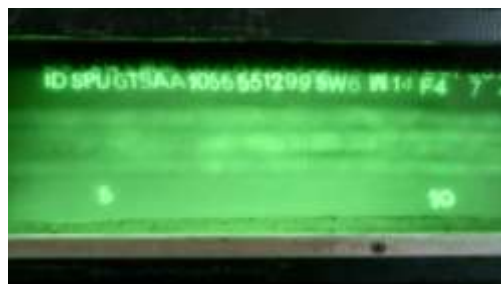
Figure 2. Film test results on welding sections of 5-10 inches

The results of the table show that there is one welding result that has a weld defect in the form of porosity along 1 mm at the weld joint as shown by Radiographic film no.4 (four), but the weld defect is still acceptable based on the ASME B31 standard.

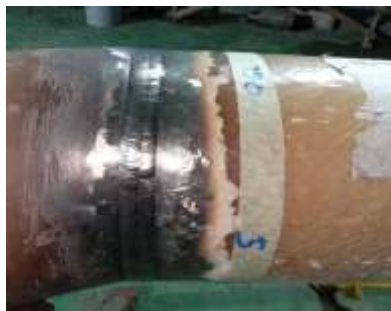
Radiographic testing was carried out on 10 (ten) sections of ASTM A790 Duplex Stainless-steel pipe material with a diameter of 8 inches with a thickness of 12.7 mm, then one of the welded surfaces is shown in Figure 3 below:

Figure 3 Surface results of welding sections 0-5 inch

Welding uses the GTAW-SMAW welding method. The test results and radiographic film observations showed that there were no weld defects in that part. This 0-5 inch section is marked with film code 1 (one)/sheet 1 (one), the film test results are shown in Figure 4 below:

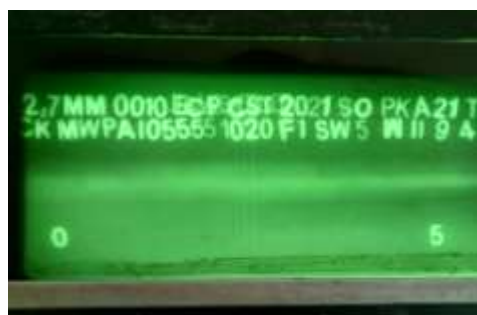
Figure 4. Film test results on welding sections 0-5 inches

Table From the table of radiographic film observations, it shows that there are no weld defects in all the Duplex Stainless-steel pipes tested, so that all pipe materials can be used.

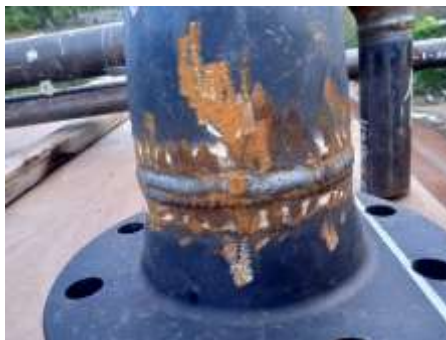
*Penetrant Test* carried out on 6 (six) sections of ASME SA 106 Carbon Steel pipe material with a diameter of 6 inches with a thickness of 14.27 mm, then one of the welded surfaces before being cleaned by a cleaner is shown in Figure 5 below:

Figure 5 Surface results of side 1 CS welding

Welding uses the GTAW-SMAW welding method. This Carbon Steel pipe is then cleaned using SKC-S cleaner fluid and the help of a rag tool. Furthermore, the surface is sprayed with penetrant liquid as shown in Figure 6 below:

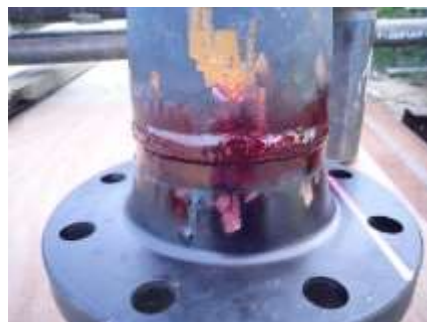
Figure 6 Application of penetrant liquid on side 1 CS

All welded surfaces are treated with SKL-SP1 penetrant liquid and the dwell time is waited for 5 minutes until it is felt that the liquid has entered the surface weld defect gap. After that, the penetrant liquid is cleaned with running water or cleaner fluid and rags. Then the welding surface is sprayed with developer liquid as shown in Figure 7 below:

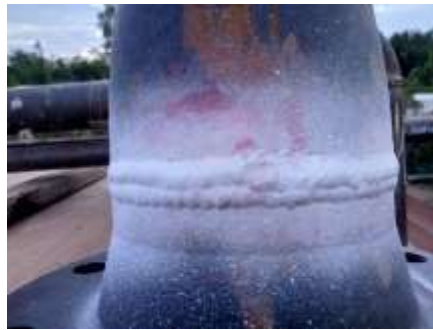
Figure 7 Application of liquid developer on side 1 CS

The welding surface is sprayed with SKD-S2 developer liquid and the interpretation time is waited for 10 minutes, so that if there are defects on the surface of the object, spots of penetrant liquid will appear on the surface of the welding result. In this test there is a weld defect in the form of porosity along 1 mm. This surface is marked with the name side 1.

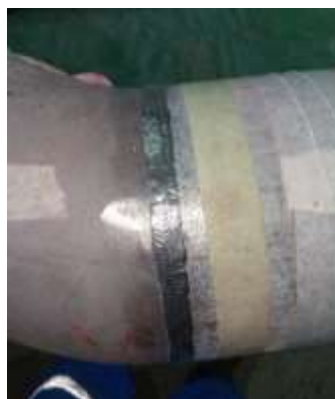
*Penetrant Test* carried out on 10 (ten) sections of ASTM A790 Duplex Stainless-steel pipe material with a diameter of 8 inches with a thickness of 12.7 mm, then one of the welded surfaces before being cleaned by a cleaner is shown in Figure 8 below:

Figure 8 Surface results of side 6 DSS welding

Welding uses the GTAW-SMAW welding method. This Duplex Stainless-steel pipe is then cleaned using SKC-S cleaner liquid and the help of a garbage tool. Furthermore, the surface is sprayed with penetrant liquid as shown in Figure 9 below:

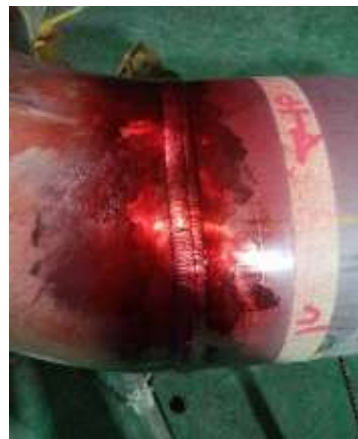
Figure 9 Application of penetrant liquid on the 6 side of the DSS

All welded surfaces were given SKL-SP1 penetrant liquid and waited for a dwell time of 10 minutes until it was felt that the liquid had entered the surface weld defect gap. After that, the penetrant liquid is cleaned with running water or cleaner fluid and rags. Then the welding surface is sprayed with developer liquid as shown in Figure 10 below:

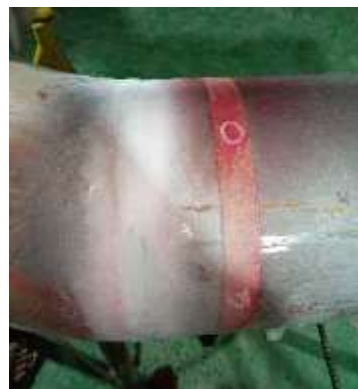
Figure 10 Application of liquid developer on the 6 side of the DSS

The welding surface is sprayed with SKD-S2 developer liquid and the interpretation time is waited for 10 minutes, so that if there are defects on the surface of the object, spots of penetrant liquid will appear on the surface of the welding result. In this test there is no indication of defects on the surface of the welding results. This surface is marked with the name side 6.
